CASE STUDY: CONDOR HOUSE, ST PAUL'S LONDON

Fire Detection and Voice Alarm Upgrade by WFP Fire & Security Completed January 2019

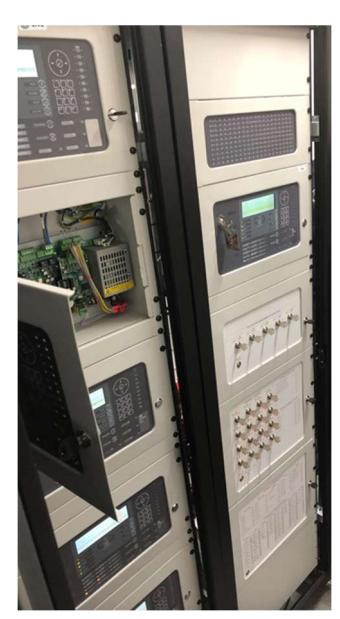
The outgoing Simplex system was a single integrated fire alarm, voice alarm, fire

telephone, and sprinkler indication system. It consisted of eight bespoke cabinets; each with a high-level power supply, two cabinets with banks of batteries and four double-sized bespoke cabinets containing amplifiers for the voice alarm system.

The replacement system would be housed inside three mobile racking units with removeable side and rear access panels; one rack dedicated to the voice alarm, and the other two racks containing the six 4-loop fire alarm panels and associated power supplies, 200 zonal indicators, sprinkler indication, bespoke plant with key switch isolation controls.

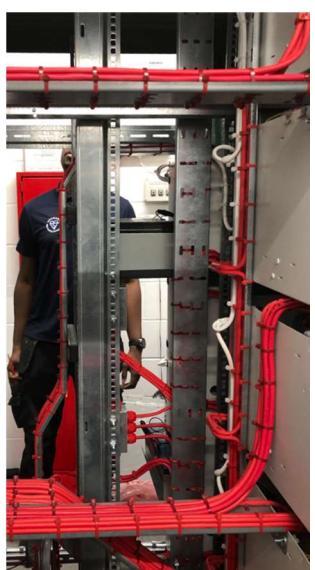
- Blacked-out door for the central rack to avoid user confusion with multiple displays
- Bespoke colour-coded fascia spacers on the front of the rack to avoid gaps between parts of the system
- Bespoke etched wording for the plant controls

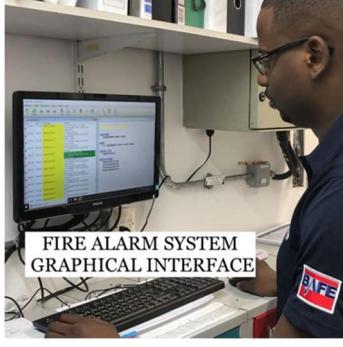
The old system had a graphics system which had become out-of-date with the various building changes and required updating with drawings and device layout. By virtue of the upgrade we were able to provide a PC based graphical interface which uses the CAD drawings

to represent the location of the detectors and provides a simple list-based method of controlling the fire alarm system without leaving the security office.

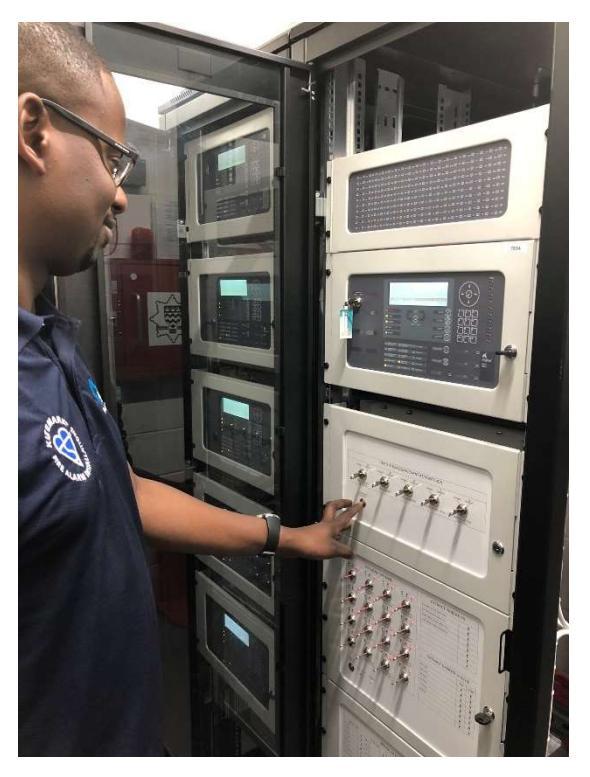
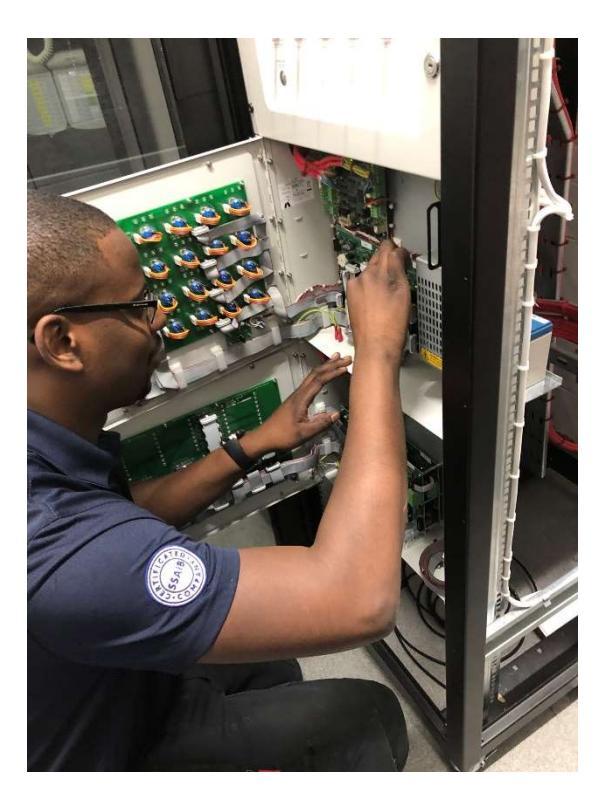
Bespoke Racking for Panels and Inside the Panels:

Our contract manager, Scott Wright, researched and designed the new system racks in-house, with a view to providing:

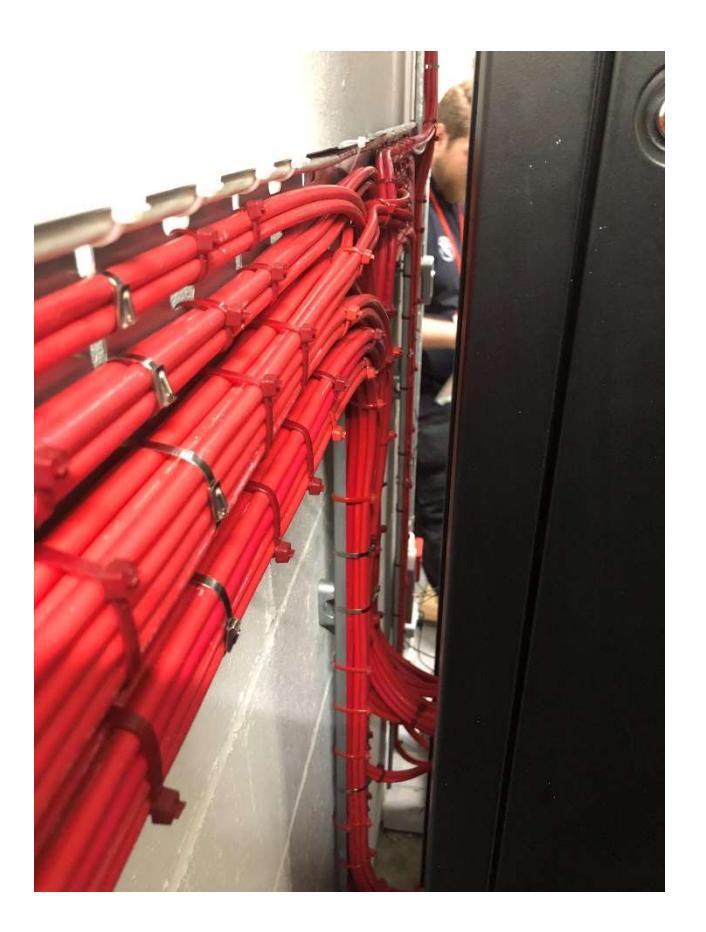
Cable Trunking:

As part of the design, Scott created specifically constructed supports for the cable ways made using Unistrut® containment access for batteries and images of the internal cabling.
